HISTORIC STRUCTURE REPORT

THE PARSON CAPEN HOUSE

The Topsfield Historical Society
Topsfield, Massachusetts

APRIL 1 2002

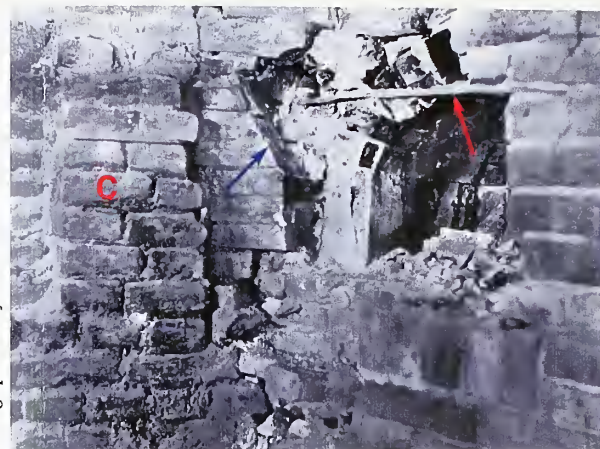
9.2: Bake oven in 1913 after removal of some face brick associated with the later rebuilding of the oven. Appleton's notes indicated the brickwork at the left jamb (blue arrow) was a remnant that formed the spring of the arch of the original bake oven. This provided the evidence for both the position of the original oven, and the layout of its arch. The horizontal piece (red arrow) was the iron lintel for the later bake oven. The eroded mortar in the pier on the left side (C) appears to be the original clay, whereas the masonry at the right side of the oven is lime based.

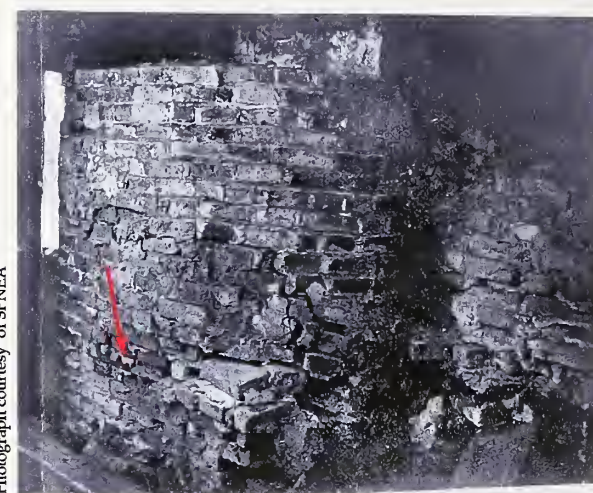
9.3

9.3: 1913 photo of the rear of the hall fireplace as visible from the back of the building after the sheathing and framing of the chimney bay had been removed. One can clearly see in this photo that most of the visible mortar is lime based rather than the original clay (note how it oozes out of the joints at the left side (arrow), which clay does not do).

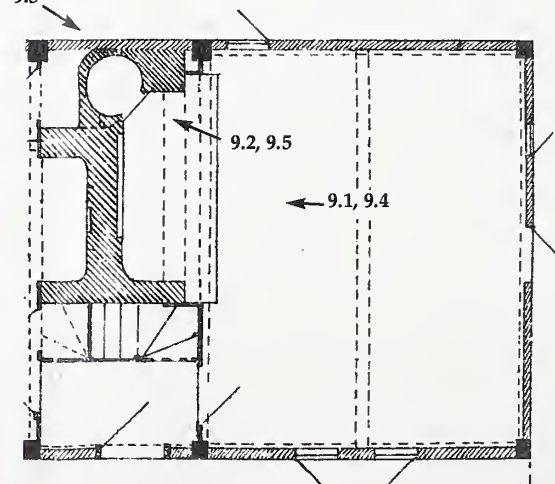
9.6: Plan of hall.

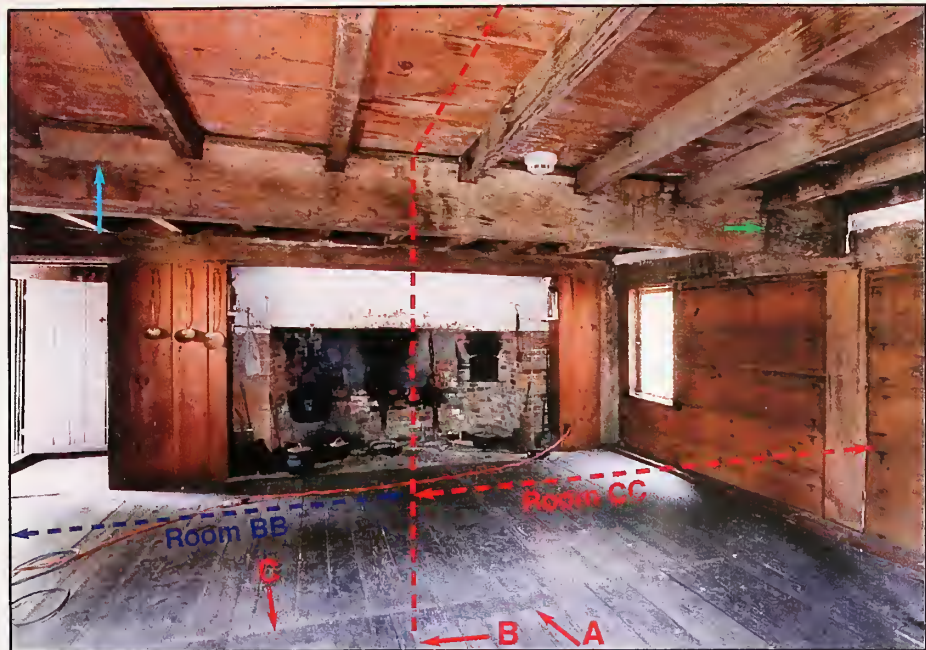
10.1: Hall summer beam showing variations in surface color that may reflect former partitions and room treatments. The line of the 19th century ceiling located on the underside of the joists is clearly visible at the left end of the summer beam (marked with blue arrow). The darker area probably had multiple coats of oil paint, while the light upper area above the joist line had only early whitewash. The relatively light section of the beam at the right side roughly coincides with the small northeast room labeled CC on 10.6 (dotted line marks partition), and may indicate that the room was always whitewashed. What the short dark section at the extreme right end (green arrow) indicates is not clear. Paint shadows on the floor (arrow A) and the adjacent cut line in floor boards arrow C) align to this face of the summer beam. Arrow B marks the paint shadow of the partition between rooms BB and CC.

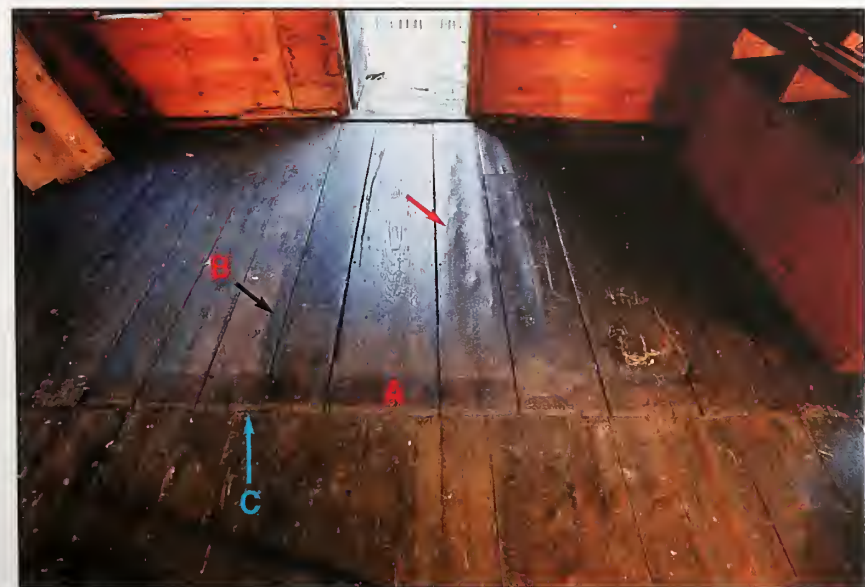
10.7: Hall floor showing paint shadow from former partitions (marked A and B), heavy wear pattern presumably from exterior door to a door into the kitchen (red arrow), and junction between two sets of floor boards aligning with former partition (blue arrow C).

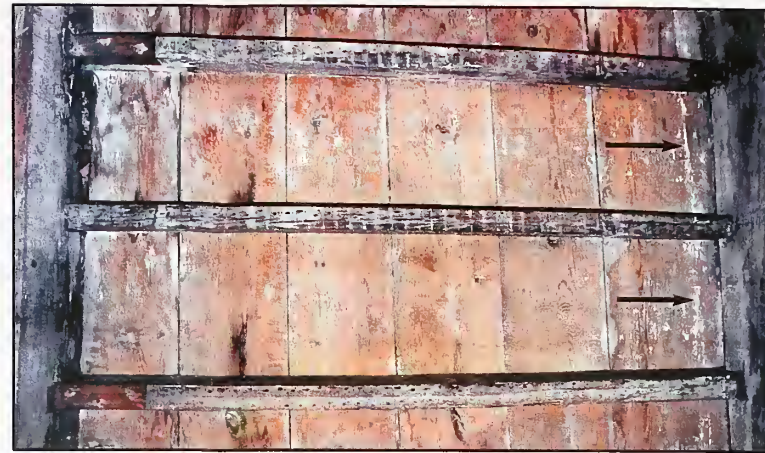
10.2: Hall ceiling joists showing uniform plaster burn (white lines) and nailing pattern from mill sawn 19th century lath. This indicates the first plaster ceiling was not installed until c. the 1830s or later. The uniform white paint lines adjacent to the summer beam (arrows) suggests the room partition predates the plaster ceiling.

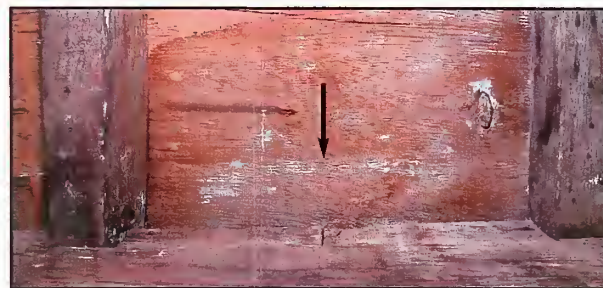
10.4: Closeup of white paint line on ceiling boards next to summer beam that may reflect the line of a former board partition. The wood color is slightly lighter on the beam side of the line.

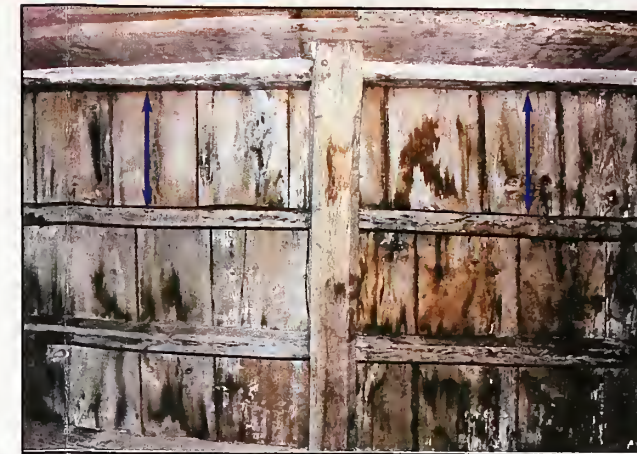
10.3: The boards in the last (i.e., north) bay of the ceiling (arrows) are short pieces suggesting some unknown past repair or alteration. The other boards span the entire room.

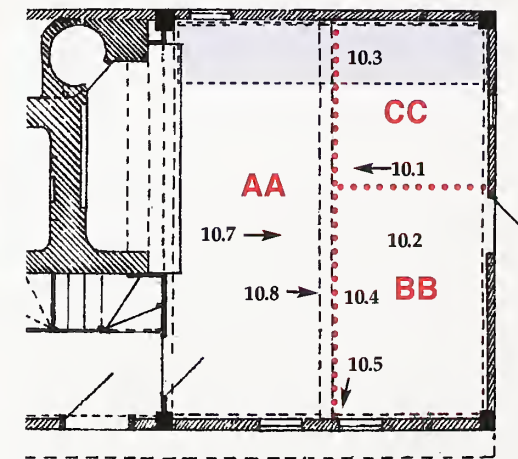
10.6 Plan of hall with photo locations. Dotted red line indicates partitions removed by Dow. Paint lines on the ceiling boards (see 10.2 and 10.4) suggest the partitions go back to the 18th century before the plaster ceiling was installed. However, the presence of whitewash remnants on the top beveled surface of the summer beam that would have been covered by the partition suggest that the partition was not an original feature. The rooms marked BB and CC were probably kitchen service spaces. The floor boards in the blue area were replaced by Dow. The age of the remaining floor boards is unknown, but likely not original. The subflooring boards extend the full width of the hall, while the finish boards are cut at the partition line.

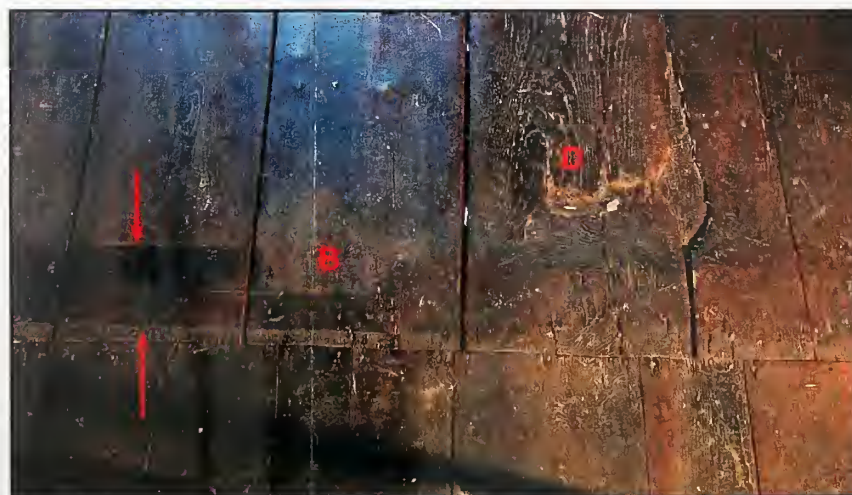
10.8: Close up of paint shadows relating to former hall partition. The very heavy wear marked D probably indicates the former door location. Remnants of multiple layers of yellow ochre paint on the floor are clearly visible along the partition line (arrows). The meaning of the rectangular paint indentation marked B is not clear. While similar yellow ochre paint remnants are present on both sides of the cut line, most specific patches of paint do not lap across the cut line. This suggests the cut reflects a repair with the boards on the fireplace side being old replacement boards (they also show areas of heavy wear). Most visible nails appear to be cut rather than wrought, but none were pulled to verify their type.

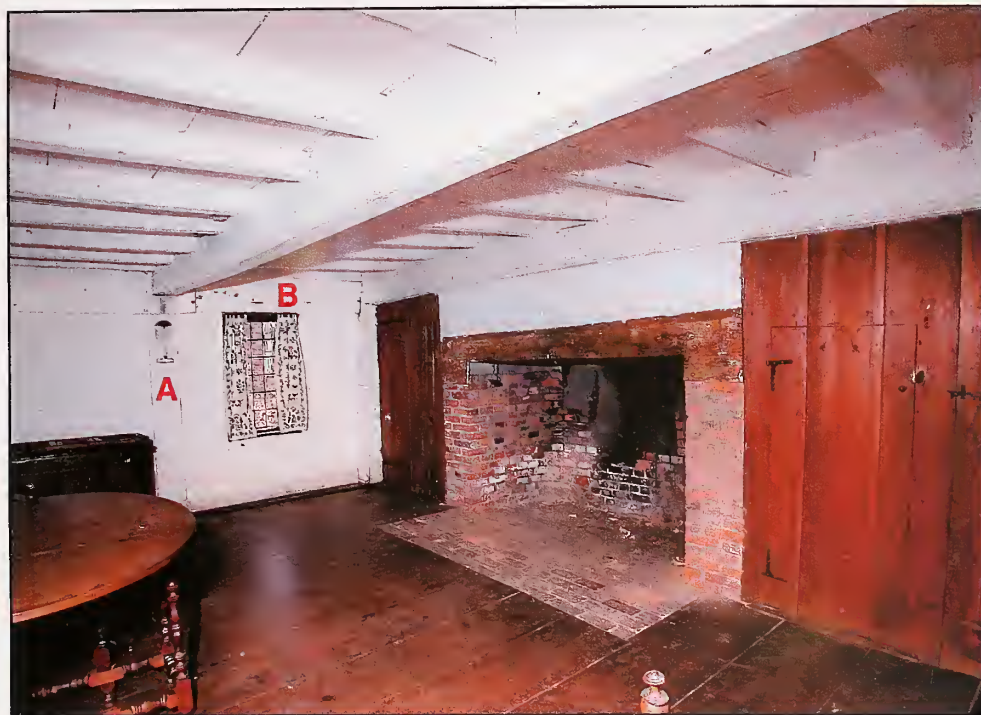
11.1: Current appearance of hall north and west walls. The original floorboards were replaced by Dow in 1913 along with a new fireplace hearth. The vertical feather edged sheathing and doors flanking the fireplace are Dow's replacement of the woodwork and plaster he uncovered in 1913 (see 11.3, 12.1), and match the woodwork in the hall and entry. The board at A is a restoration by Dow (see 11.5). The window is unlikely to be in an original location, as windows were not usually placed in the north wall and it conflicts with the probable location of a stud or brace. The section of the rear girt marked B above the window appears to be a very old repair that has removed the visible pin evidence for original framing in this area.

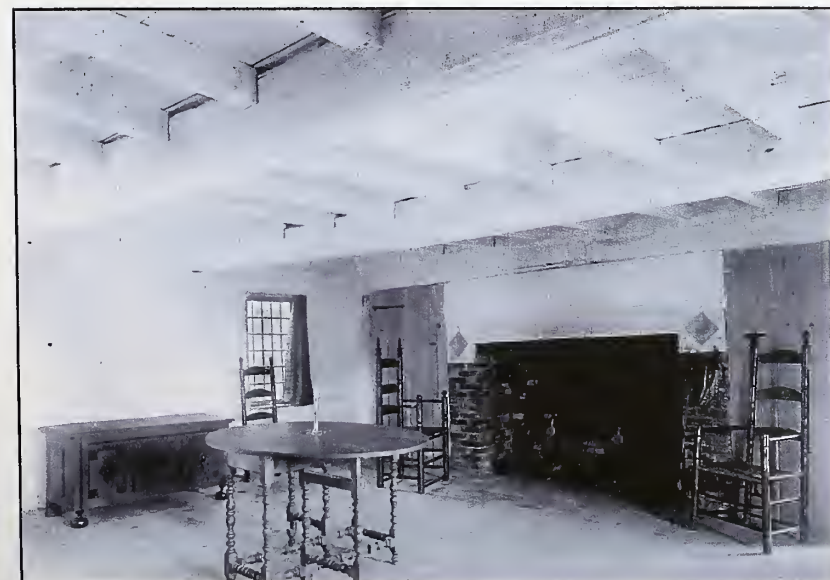
11.4: Parlor shortly after completion of the restoration in 1913. About the only difference with its current appearance is the presence of paint on the fireplace lintel coverboard and the lighter appearance of the wood sheathing flanking the fireplace. The diamond shapes on the coverboard are probably tin sconces. Dow did not strip the paint from the ceiling as he did in the hall. The beams below the former ceiling line retain their full paint history, and fragments of earlier whitewash remain above the plaster line under the modern paint.

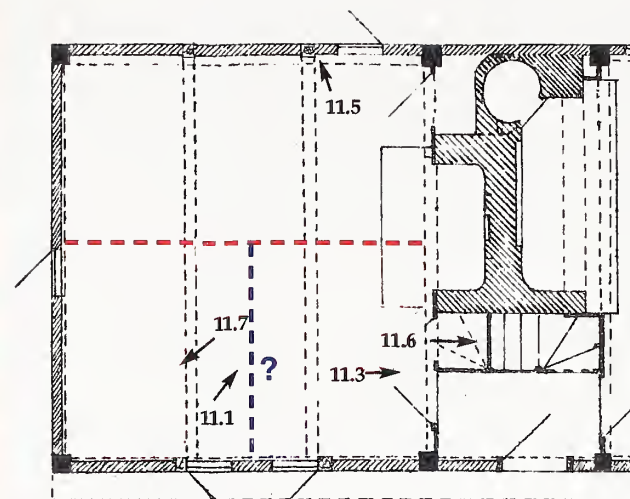
11.2: Plan of Parlor. Dashed red line indicates former 19th century partition based on paint lines on chimney girt in 1913 photo (see 12.1) and still visible as shadows on the chimney girt and east early summer beam. Paint shadows were not found on the west end girt, however. The blue dashed line is the conjectural location of another 19th century partition based on an 1894 newspaper article that stated there were then six rooms within the two first floor rooms. No paint shadows were found to locate this partition, but the late 19th century window locations make this the most logical location.

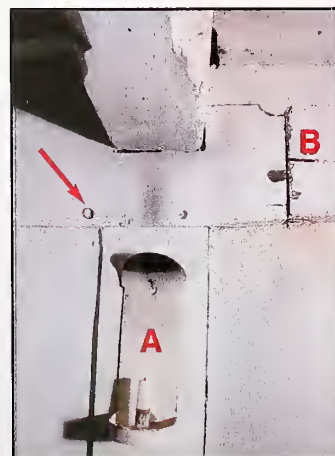
11.5: Detail of north wall showing post restored by Dow (A) based on pin evidence and the similar original posts in the parlor chamber. Dow neatly aligned the post to the summer beam rather than the slightly off-center pins (arrow), and used a 1" thick board to not interfere with the new wall framing (see sheet 17 for new framing). The line at B marks the start of an old girt repair.

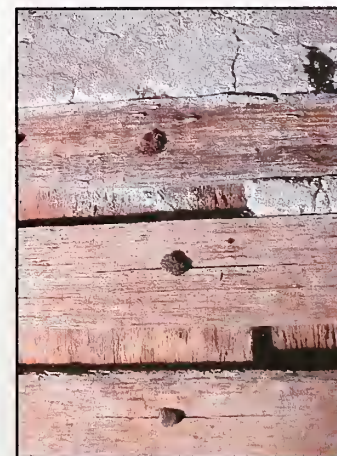
11.6: Lath and plaster at rear of parlor closet under stairs. lath are oak (possibly reused portions of original clapboards) attached with wrought nails. The plaster is lime based rather than clay. As clay appears to have been used for original plaster (see parlor chamber; 14.2 and 14.3), this installation is likely 18th century rather than original.

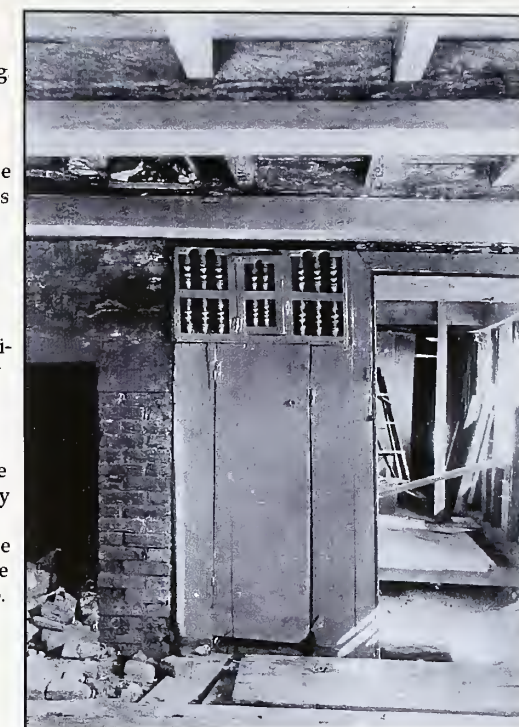
11.3: 1913 photo looking from parlor through entry into the hall beyond showing the plain, unmolded board sheathing and trim replaced by Dow with feather edge sheathing. The location of the 19th century plaster ceiling is obvious from the paint on the summer beams. The photo also shows the extent of whitewash fragments remaining above the plaster ceiling and the as found position of the first period livery cupboard facing. Note the stair hall floor is entirely removed showing the high level of the dirt below it. The original framing for the entry floor was probably sleepers laid directly in the soil. These eventually rotted causing the floor level to gradually drop. Dow apparently rebuilt the entry floor and staircase at the level he found rather than raising it to match the adjacent rooms.

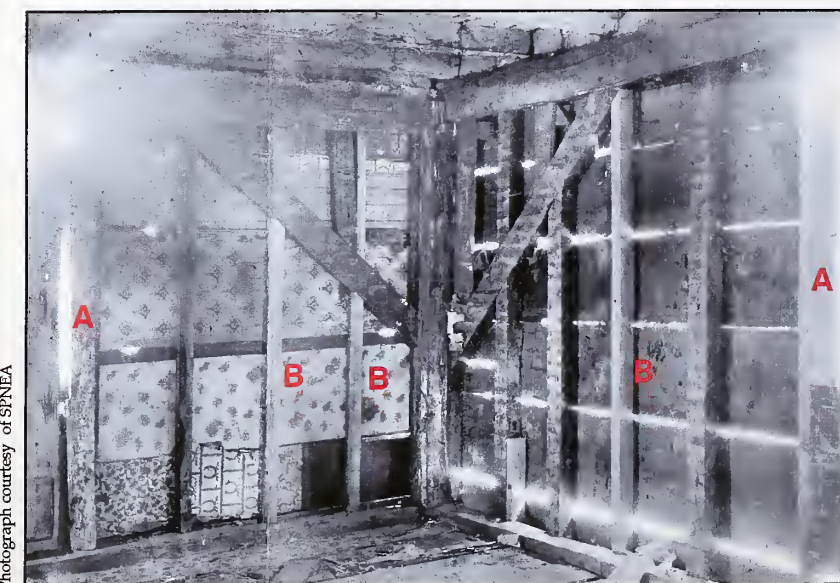
11.7: Southwest corner of parlor in 1913 following completion of structural repairs showing oversized original window studs at extreme left and right sides (A), several new studs introduced by Dow (B), and new sills. Note wallpaper on late 18th or 19th century interior board partitions reused by Dow for wall sheathing and subflooring.

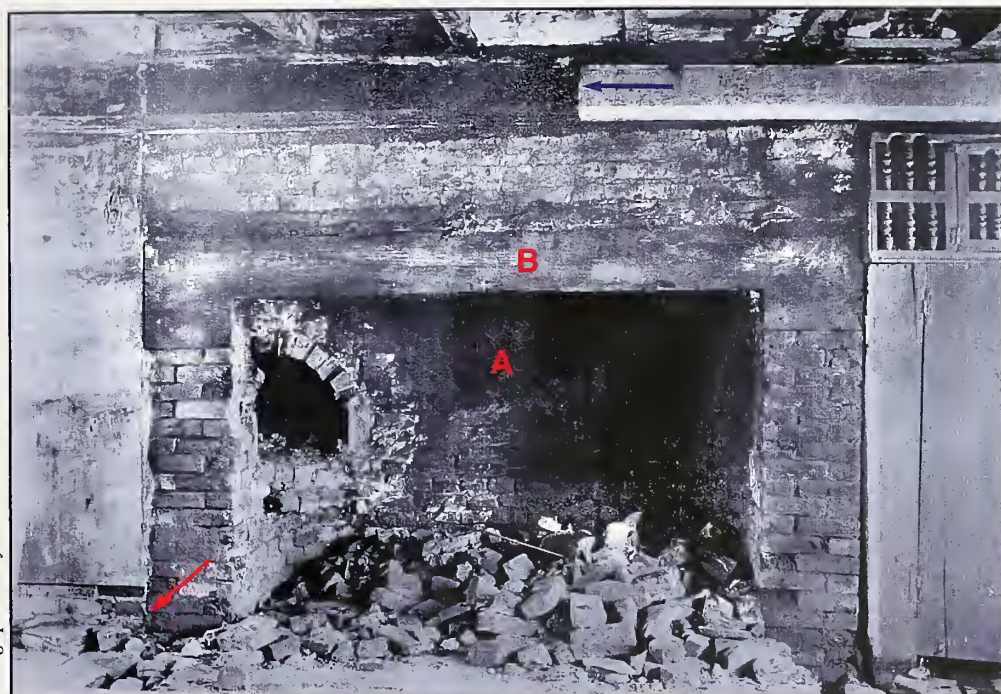
12.1: Parlor fireplace in 1913 as revealed by removal of later infill material and 18th century panel and jambs (12.2). Note rear inset panel (A), curved back corners, and coverboard over lintel (B). Appleton's notes on the photo stated the oven and wood work below the turned work are not original construction. The change in paint color on the chimney girt (blue arrow) is from a 19th century partition. The continuous vertical joint in the bricks at the lower left side of the left pier (red arrow) verifies that this was the limit of the original fireplace.

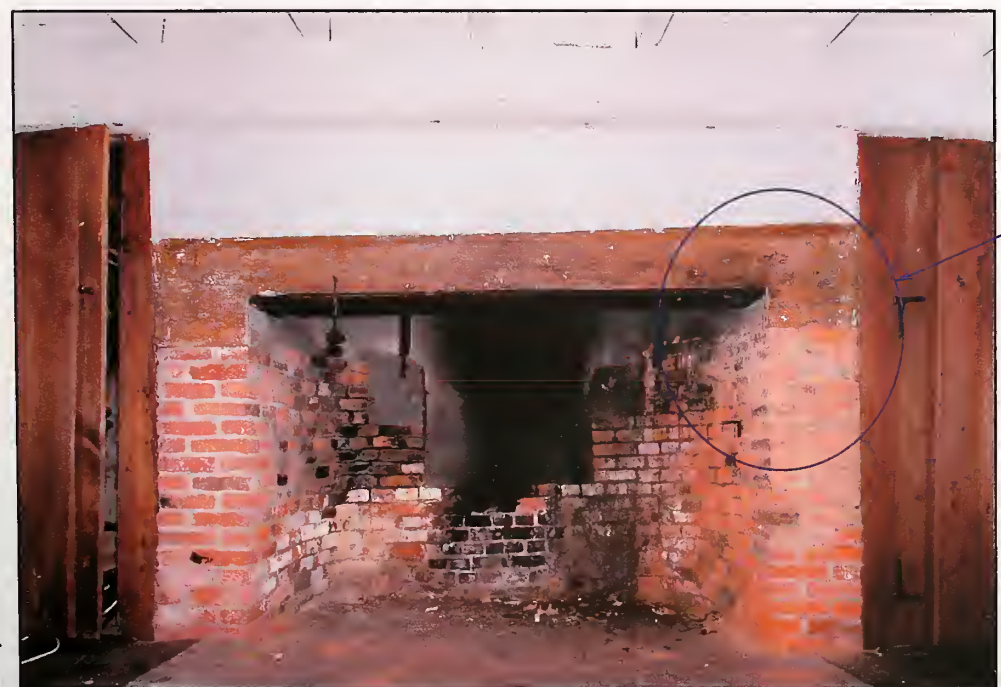
12.5: Current appearance of parlor fireplace. The overall design with curved corners and inset rear panel is substantiated by the 1913 photo. The right pier, right back corner, and the lintel coverboard are largely original material with remaining traces of the original clay mortar. The left side is largely rebuilt. The application of grey cement parging to the inset panel and adjoining piers is a recent treatment, perhaps in 1972.

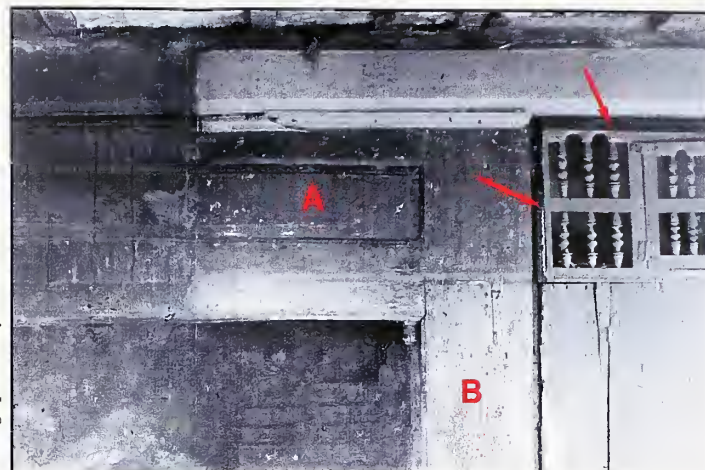
12.2: Parlor fireplace in 1913 before the removal of 18th century panel (A) and jamb covers (B). The woodwork with turnings is described by Appleton as a hanging cupboard. The paint lines around its edges where moldings have been removed (arrows) suggest it had been in this position since the 18th century.

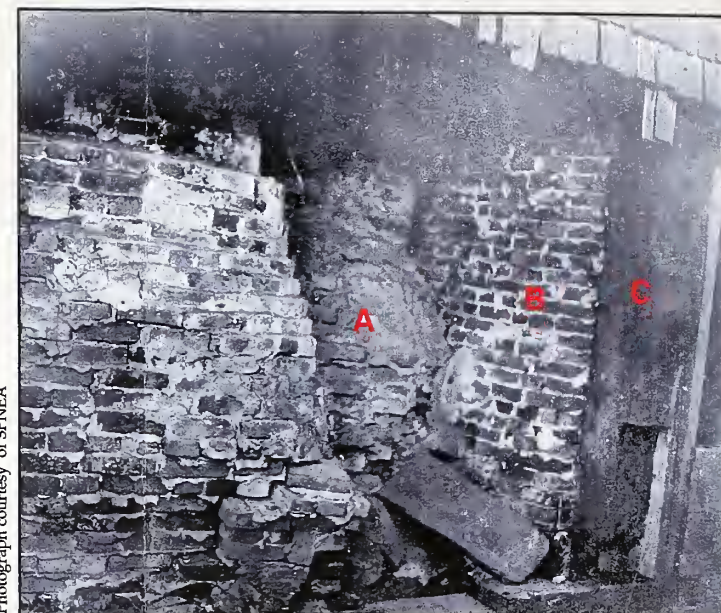
12.3: Fireplace brickwork viewed from the rear of the chimney bay in 1913 before restoration. The brickwork at the left is from the hall fireplace. The mound in the center (A) is bake oven in the parlor fireplace. The flat panel on the right (B) is the obviously later brick on the side of the fireplace that is plastered over in 12.1. The disjunction of oven brickwork to the panel and mortar that appears to be lime rather than clay support Appleton's observation that this was a later addition to the parlor fireplace. Also note the condition of the base of the chimney post, which has since been ended out.

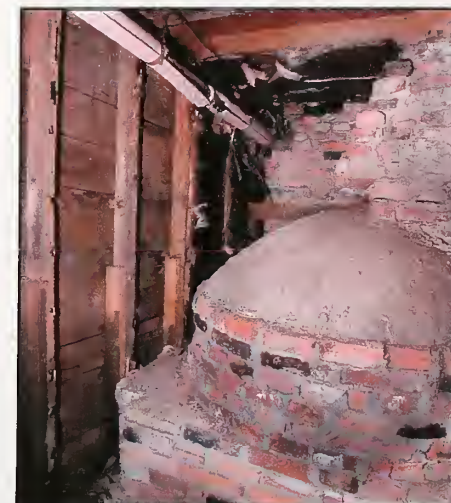
12.7: Chimney bay looking at north exterior wall with replacement studs and reconstructed hall bake oven installed by Dow in 1913.

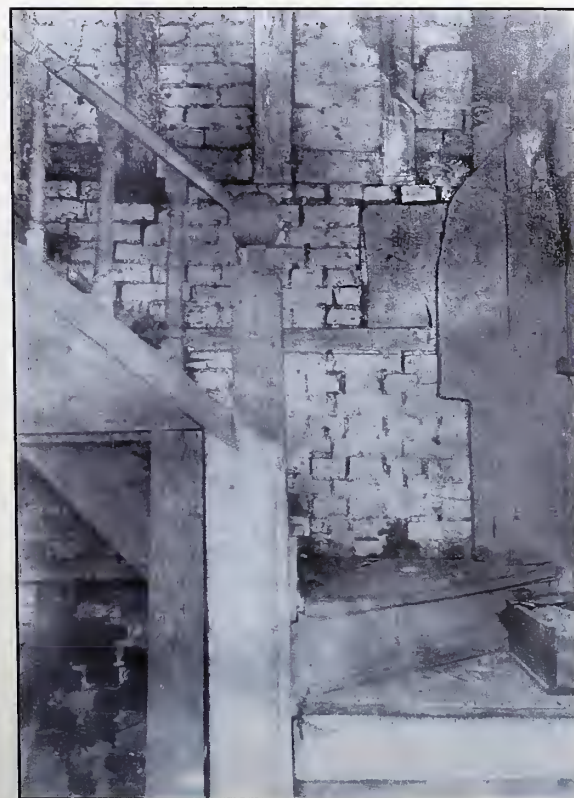
13.4: 1913 photo of stairs after existing later finishes had been removed. Comparing the tread positions in this photo with 13.1 shows that Dow reconfigured the stair treads. The 1894 newspaper article describing the house indicates the bricks were exposed at that time.

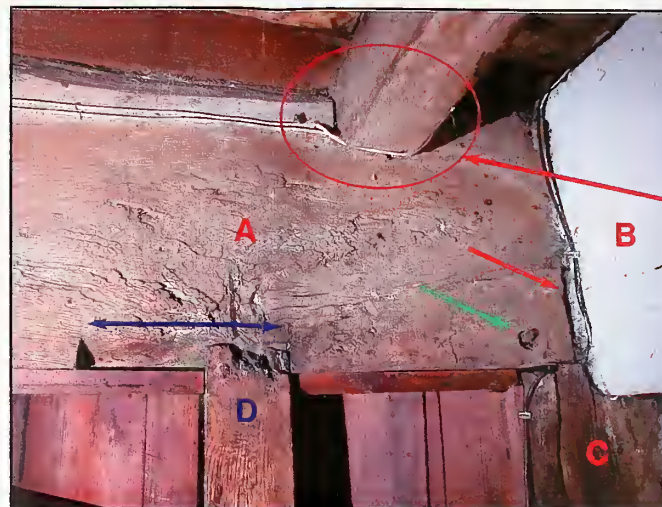
13.2: Junction of west chimney girt (A) to lower front girt (B) and chimney post (C) in first floor stair hall. Dow has placed a stud for the door jamb in an old gain (blue arrow) for a much wider member. There is a similar old wide gain at the jamb for the other side of the hall door. These gains are the only surviving evidence observed in the lower stair hall for early framing and finishes. Note the half-lap joint of the chimney girt passing over the front girt (red arrow), and the pin for the tenon from the post (green arrow). The closeness of the pin to the edge of the post suggests some of the post may have been shaved off. The east chimney post is concealed behind modern casing added by Dow to conceal the heating pipes.

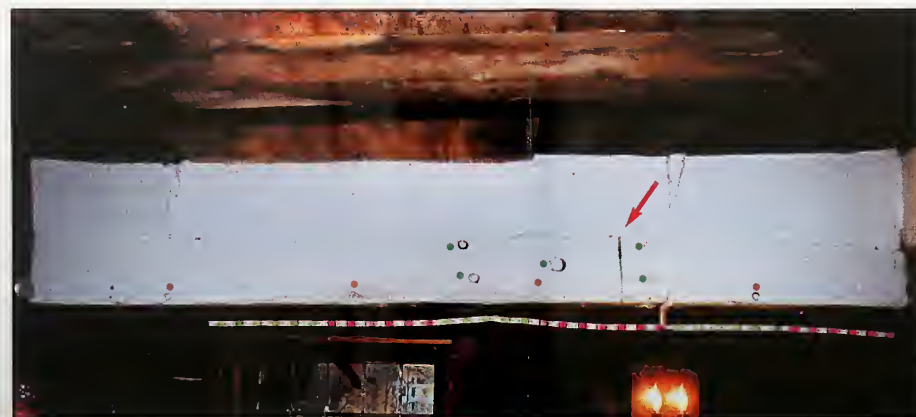
13.7: Front roof plate in second floor stair hall showing original bladed scarf joint (arrow) with its pins marked with green dots, and the pins for wall studs marked with red dots. The pin over the center of the window makes it clear the current window does not reflect the size or position of any original window in this space. A similar scarf joint is present in the rear plate, but a 19th century cover board makes it impossible to confirm the pin pattern. The front overhanging girt also once had a scarf joint in the chimney bay that has been removed by repairs.

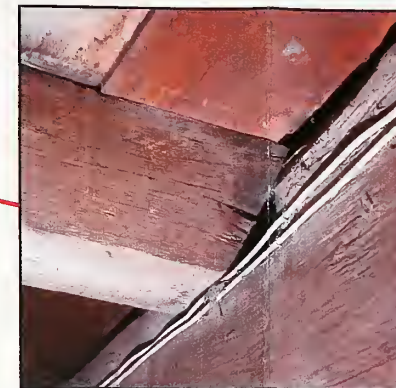
13.3: Joists at first floor stair hall ceiling are loosely fitted to diagonal gains in the chimney girts. This is an unusual detail and would appear to be structurally weak, but the floor above does not exhibit unusual deflection. The second floor ceiling joists have similar joints.

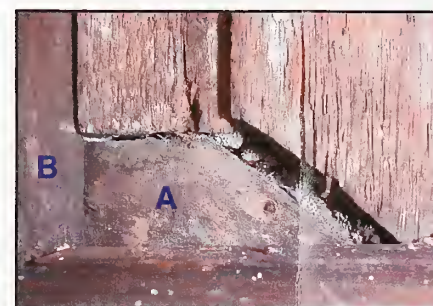
13.6: Unusual triangular shaped spline (marked A) at the base of the second floor chimney post (marked B). It is fitted into gains in both the post and the top of the chimney girt and appears to be pinned to both to function as an original reinforcement for the joint between the post, chimney girt, and overhanging front girt. A similar spline is present at the base of the west chimney post in the hall chamber.

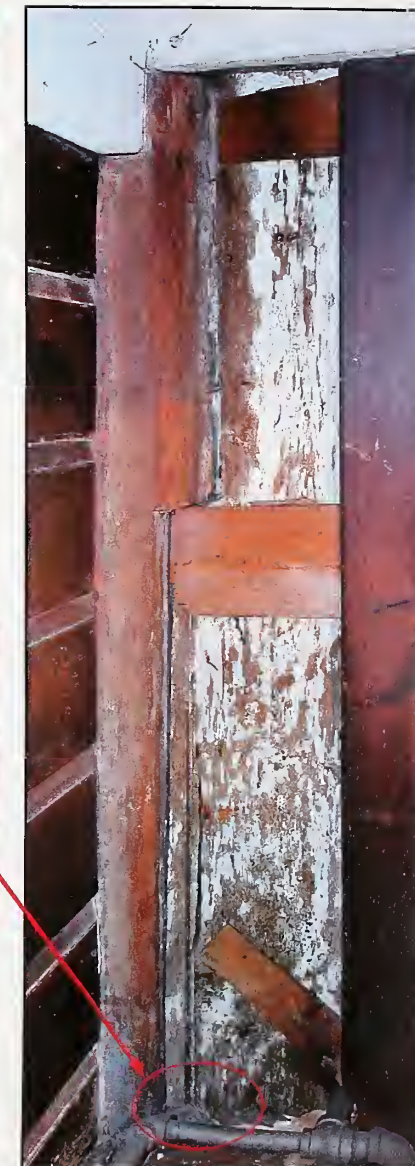
13.8: Dow's board sheathing removed at second floor east chimney post to reveal old whitewashed sheathing board scribed to the post. Whether this is a reused piece installed by Dow as a filler or is a previous finish is unclear and warrants further investigation. Based on the 1913 photos this seems characteristic of the early finishes found by Dow.

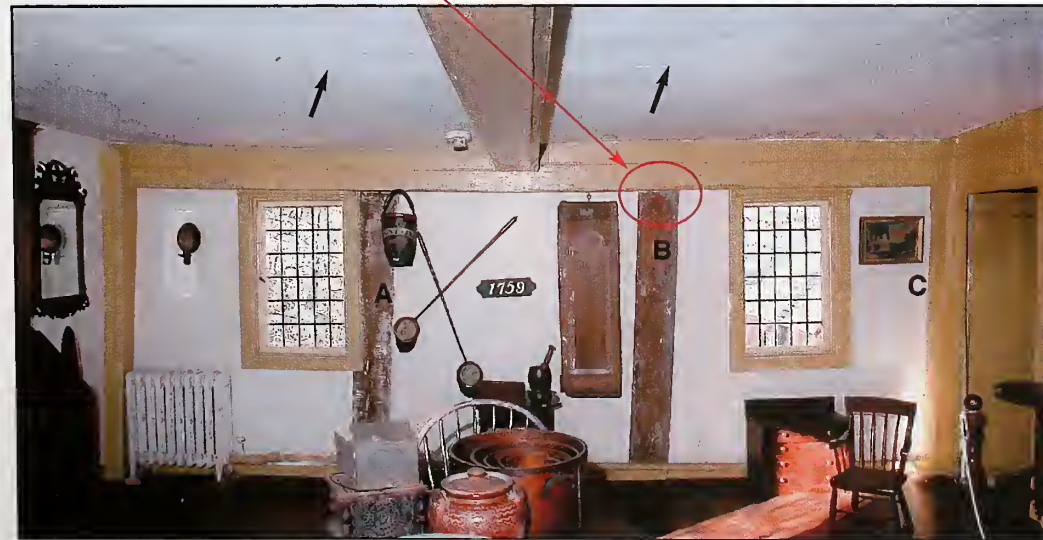
14.7: North wall of parlor chamber. Posts marked "A" and "B" are original based on pins at top and are about 4" thick. The angle of post B and the corner post at C are due to pre-Dow structural movement of the north wall, and appear to have been stable since 1913. Windows do not reflect original window position and size as they conflict with original stud and brace locations. Their placement is in the 18th/19th century window openings present in 1913. The wall was not opened to examine the studs for evidence of original windows. Arrows point to scars in the ceiling plaster marking the position of the former 19th century partition.

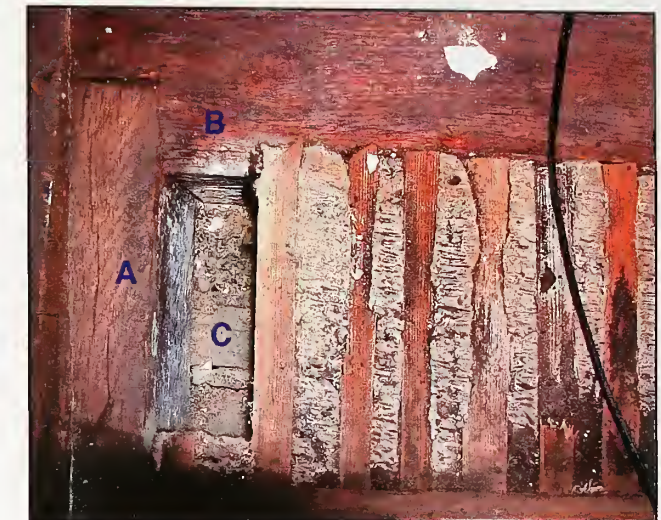
14.3: Close up of clay plaster. Note early white wash present on ceiling joist (marked A) and side of summer beam (marked B). Lath of current plaster ceiling (marked C) are visible below the joist. These predate Dow but are circular sawn. The lath for the clay plaster are riven and quite widely spaced. In contrast to the parlor closet oak lath, these appear to be pine.

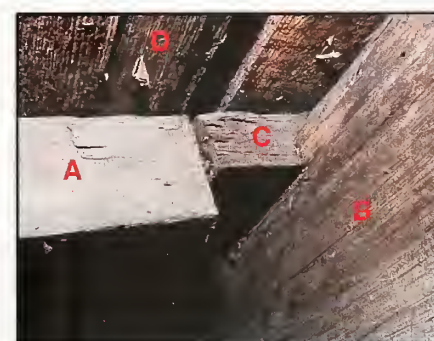
15.7: Unusual condition of purlin at east end rafter #1. Original purlin (A) has been cut short of the rafter (B) and a separate piece (C) installed in the original rafter gain. The new piece extends about 6" beyond the rafter to the restored verge boards. The original purlin extensions were cut off at the exterior face of the rafter in the 18th century when the verge boards were removed. There is no apparent connection between the original purlin and the added piece, which leaves the primary purlin end supported by the roof sheathing (D) nailed to it rather than the rafter. Presumably Dow did this to all the purlins and the end rafters. No signs of distress were observed related to this. Perhaps the side walls of the attic rooms have picked up the loads from the roof sheathing.

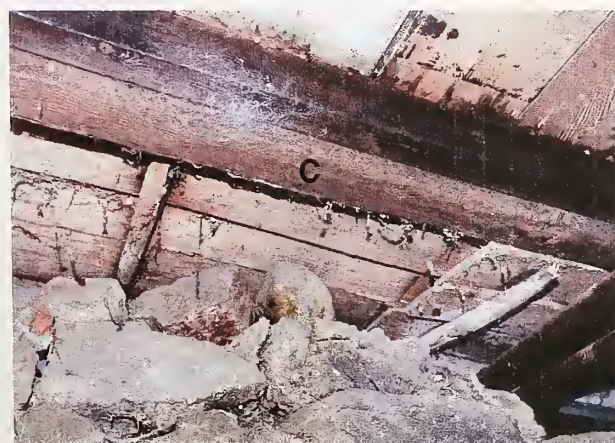
16.5: Original joist (marked C) in west basement with the only remaining bay of original floor insulation composed of clay and chopped straw supported by unused original oak clapboards carried by wood rungs spanning between joists. This is important both as the only known example of this treatment and because the oak clapboards are probably representative of the original exterior clapboards. Both Appleton and Donald Millar commented on the survival of this treatment. The remaining pieces are very important to preserve in situ. The dark wood next to the original joist is a modern sister joist.

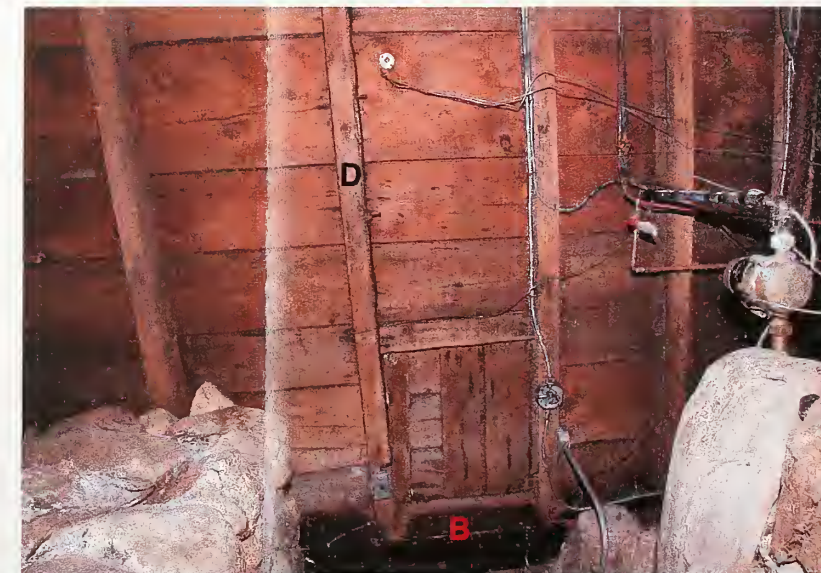
16.7: Hall sub-flooring at the front wall of the basement. The sub-floor boards are continuous across the width of the hall whereas the finish floor boards have a continuous joint aligned over the joist marked D. The subfloor is old vertically sawn boards, but, like the joists, probably not original. The sill at B is a modern replacement. All of the joists have been spliced with new wood in the last four feet towards the north wall.

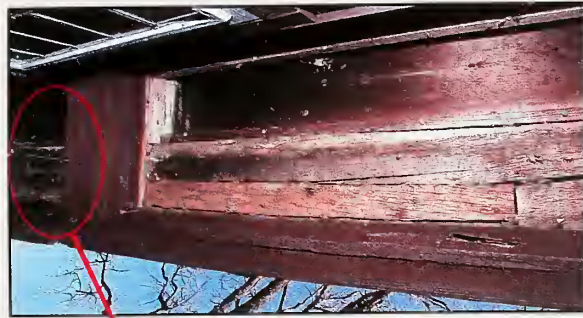
17.2: Old repair to girt with let in timber.

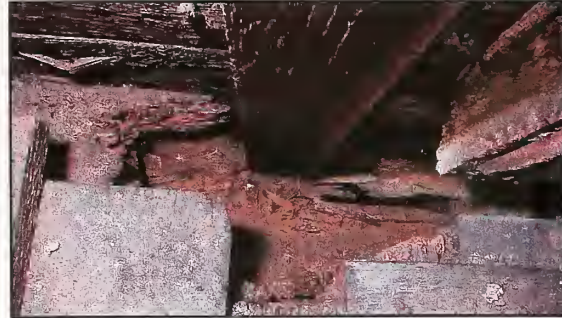
17.1: Overhanging girt heavily rotted out over summer beam from water leaking down window stud. Damage appears to be old and wall is currently stable with loads being transmitted by other members to wall below. Refer to Ocmulgee Assoc. letter report in Appendix for analysis of this and related structural issues.

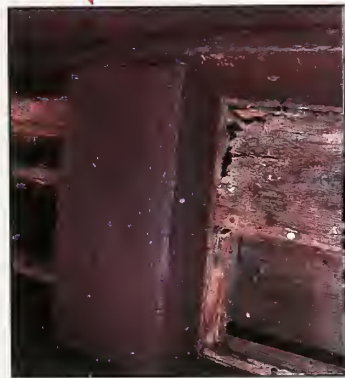
17.3: Old rot in girt over summer beam. Damage in girt on far side of summer beam has old repair with let in timber (see 17.2 above)

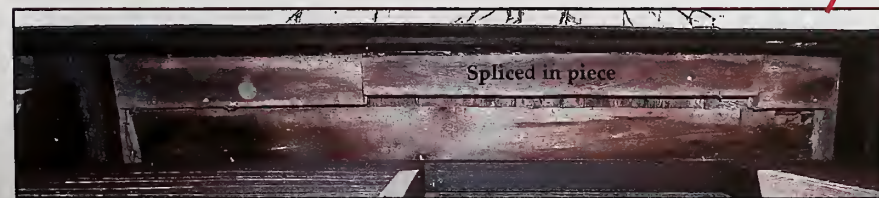
Door studs not shown; Large Dutchman in lower girt removed pin evidence.

17.6: Old repair to girt with piece spliced in.

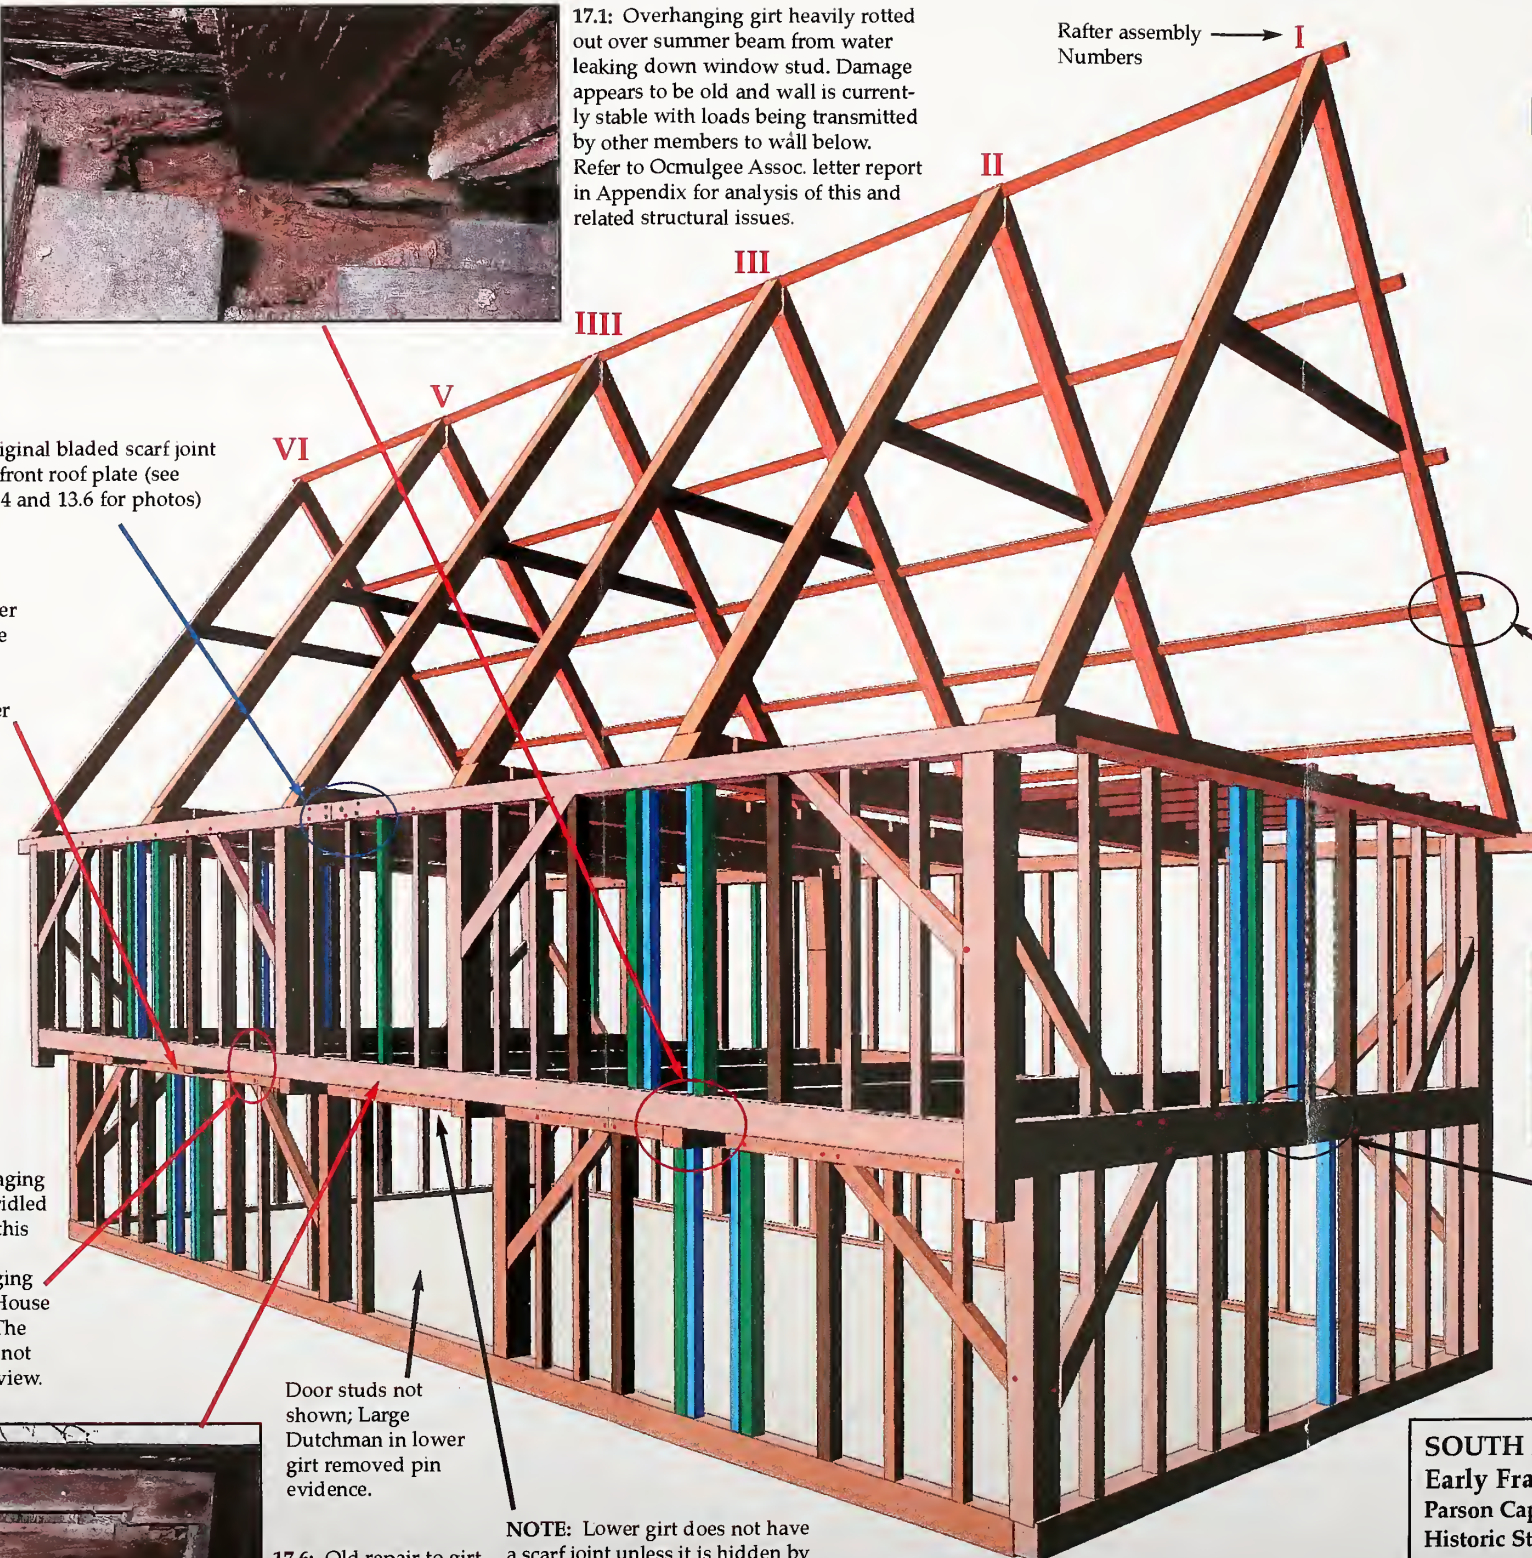
Area of past rot and insect damage in girt repaired by Dow with a crude Dutchman let into the exterior side is considered stable.

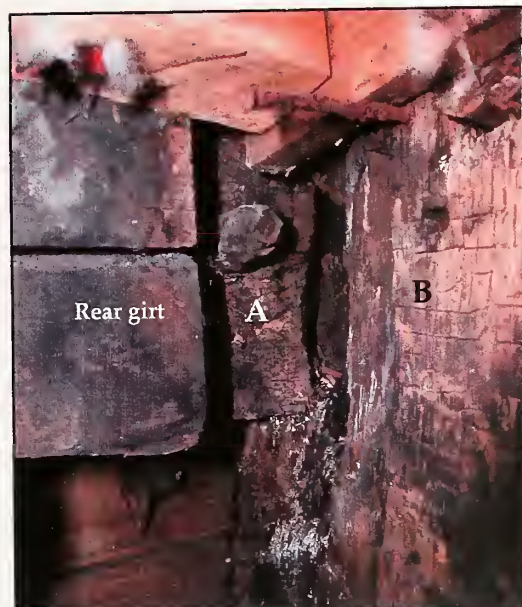
18.1: Chimney bay rear girt tenon (A) has almost completely pulled out of its mortise in the post (B) due to past movement of the frame from major rear sill deterioration repaired by Dow in 1913. The hall girt has also partially pulled out of its mortise in this post (see 8.5), and other long past movement is apparent at the roof plate/chimney posts joints (see 18.2). Currently this condition is stable with the loads being transmitted to the sills by the studs, and the frame being effectively tied together by the sheathing rather than the pinned joints. Refer to Ocmulgee Assoc. letter report in Appendix for analysis of this and related structural issues.

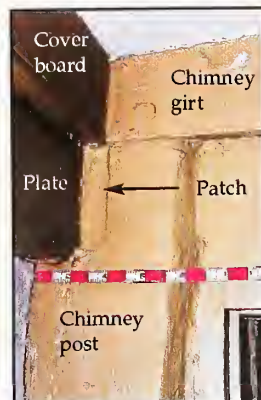
18.2: Long past movement of rear wall framing outwards at the roof plate is evidenced by the wide patch in the notch for the plate at top of west chimney post. That the patch appears to be old and is not severely cracked indicates there is no substantial current movement.

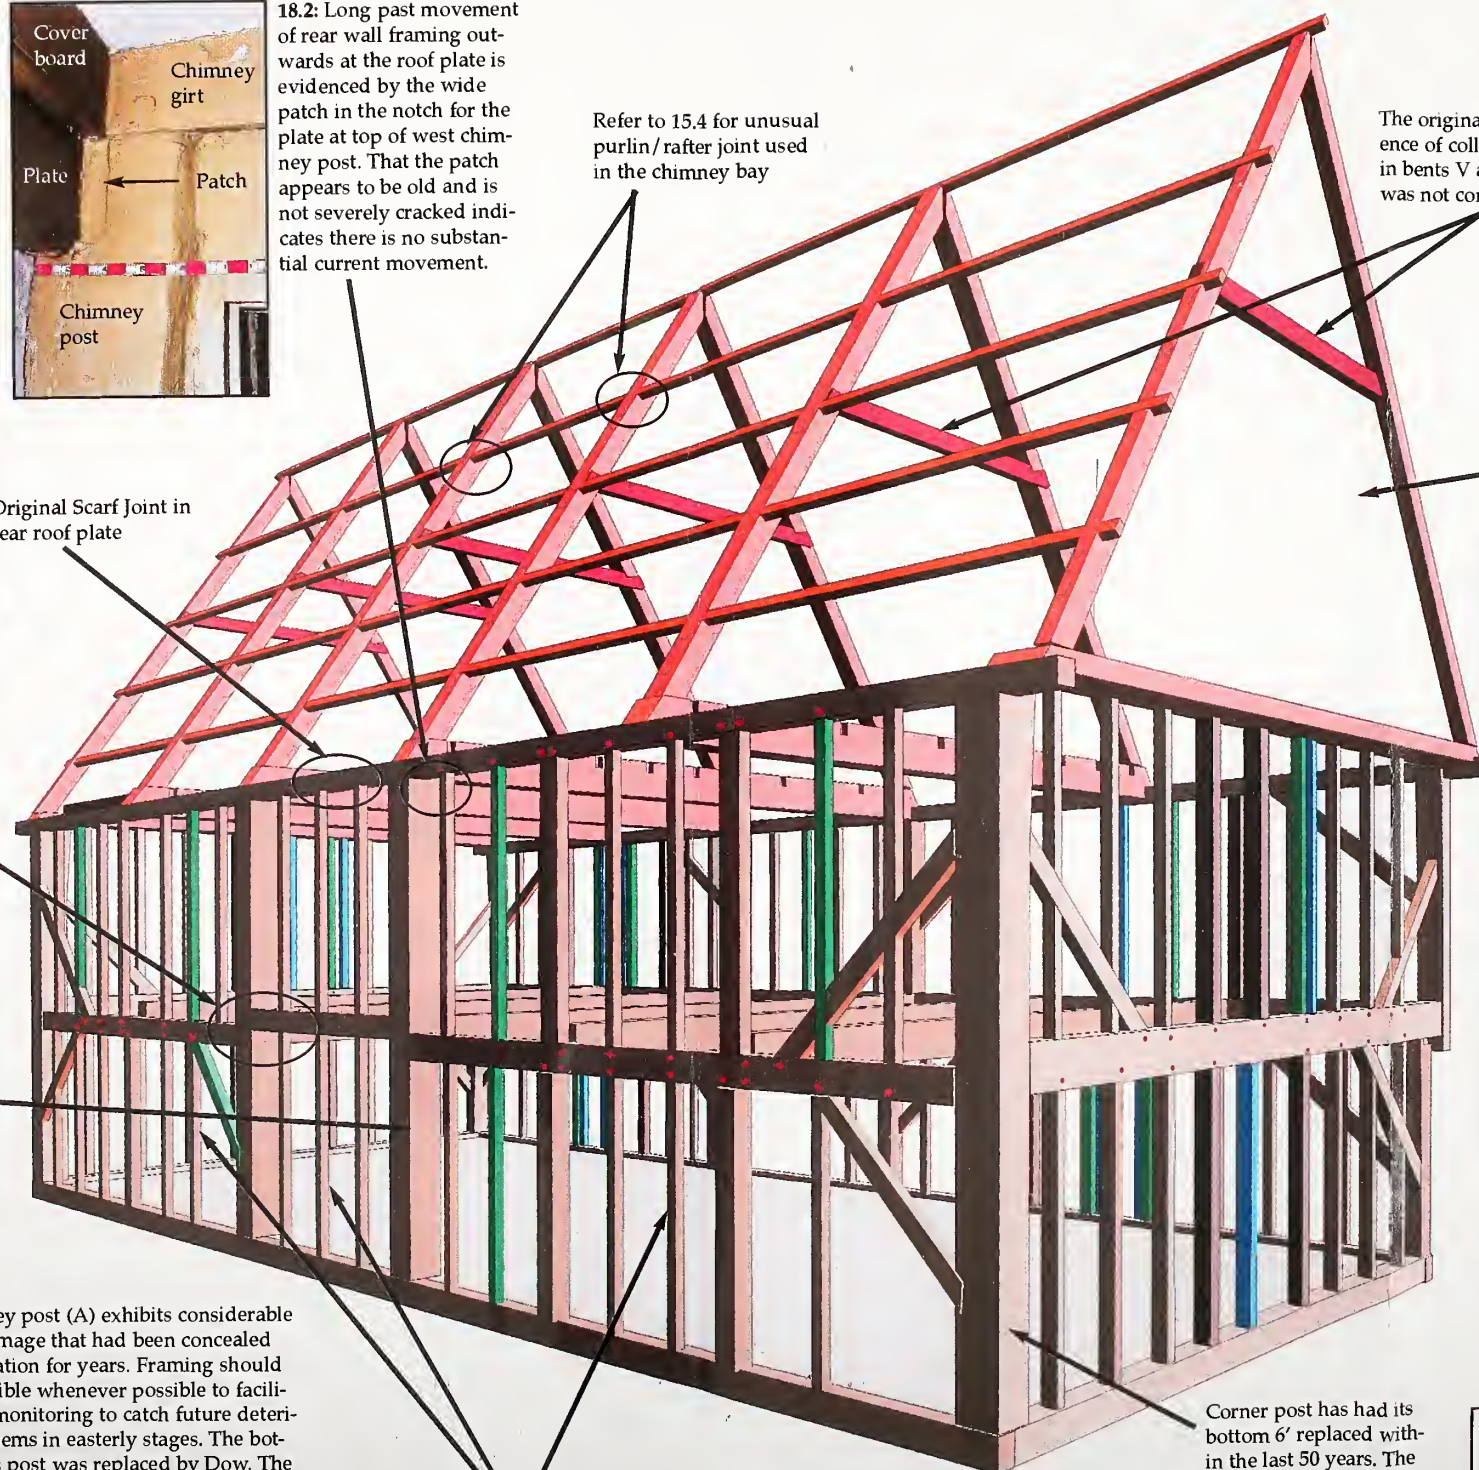
All original first floor studs and braces were replaced with 2 x 4 studs in 1913 by Dow.

Corner post has had its bottom 6' replaced within the last 50 years. The post is substantially out of plumb.
